“Swithland slate” and St Paul’s Church, Woodhouse Eaves.

By Sue Young

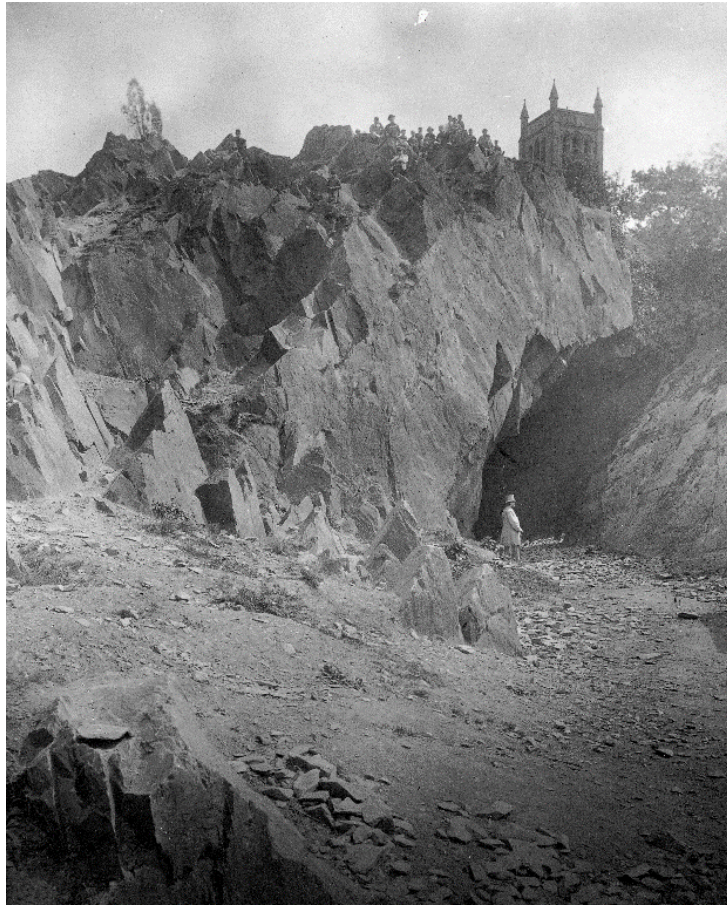
Photo 1- Picture of Stone Hole and St Paul's church in Woodhouse eaves, courtesy of British Geological Survey (Supplied under EA 18-030)

The main quarrying took place in 18th and 19th centuries in Swithland, The Brand, Groby and Woodhouse Eaves (*photo 1*).³ Production ceased at the end of the 19th century although some, already quarried, material was still being sold locally on a small scale, at the turn of the century.⁴

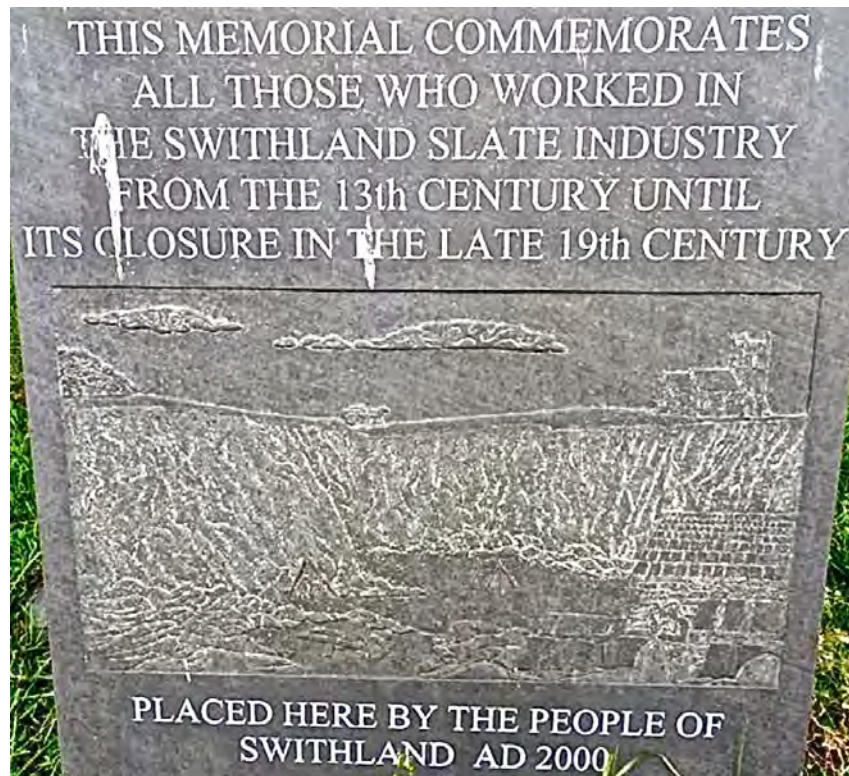
Photo 2 - Swithland Village memorial to slate workers, showing a pit, barrow, church and slate workers

At one time skilled craftsmen were employed specifically at some quarries to craft roof tiles and other slate products; roof tiles being the most important product sold by the Swithland quarries (*photo 2*). Only one set of accounts has ever been discovered, from 1852/1853, for the Swithland and Groby Quarries. Discovered at Enville Hall, Staffordshire, former home of the Earl of Stamford, they indicate much higher sales of roof tile slates from Swithland as compared to Groby.⁵

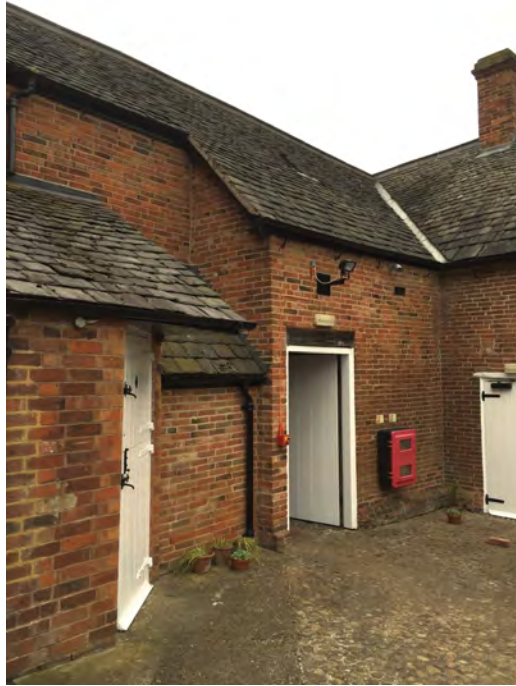
Photo 3 – Roof on outhouse buildings, Belgrave Hall, Leicester

Swithland slate roofs were purchased by local wealthy owners for their manor houses etc and were very fashionable in the 1600's, 1700's and early 1800's and they can still be seen on many old buildings including churches in Leicester (*photo 3*) and adjacent counties and towns. In the Late 17th and early 18th century roofing with Swithland slates, rough hewn, and about 1.25 inches thick was probably the rule rather than the exception for the larger houses of nobility and gentry in Leicestershire.⁶ Many of these buildings still carry Swithland slate tiled roofs. So William Railton chose the best of local materials for our church roof.

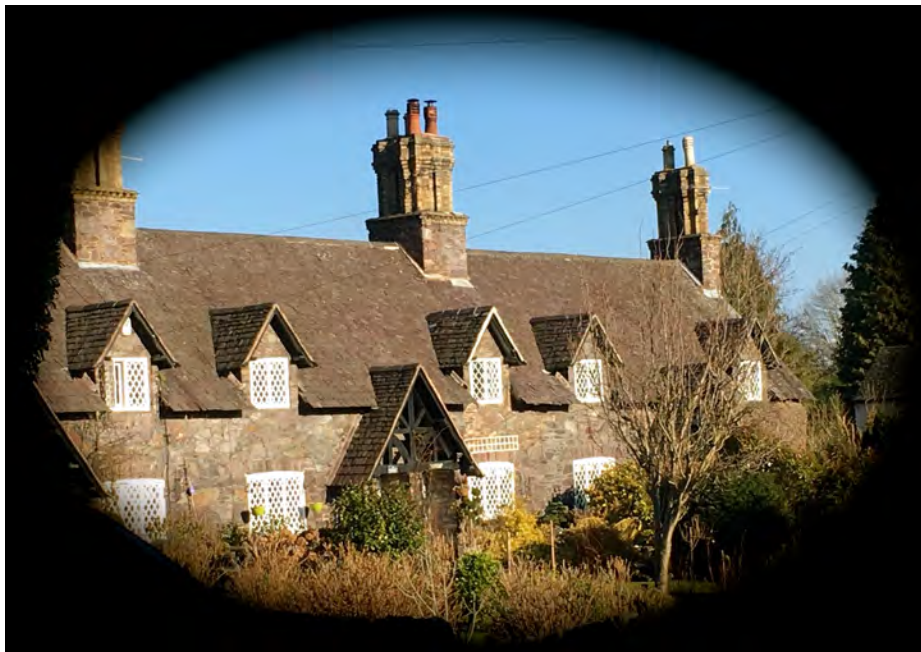
Photo 4 – Slate workers cottages, Woodhouse Eaves

Woodhouse Eaves has evidence of slate workers and the workings around it still with the beautiful slate workers cottages in the centre of the village (*photo 4*). Local roof slate production was expensive and the tiles were heavy to distribute and work with so it was superseded when the lighter and better cleaving Welsh slate started to arrive in the area, by canal. Nowadays any retrieved Swithland slate tiles are expensive to buy (over £400 per ton – from an internet search 18th February 2018) and after purchase these tiles will often need manual sorting into graded sizes before they can be used.

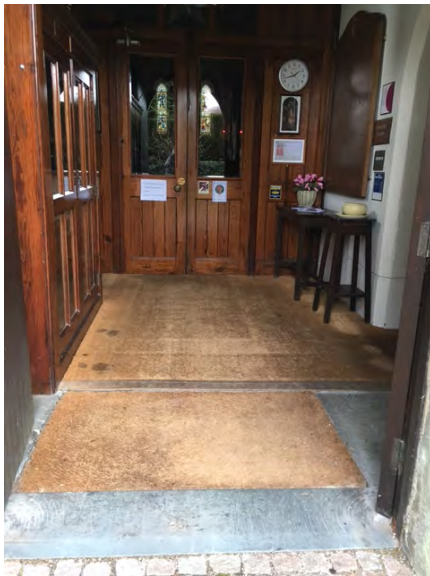
Photo 5 – Slate door sill, St Paul's Church

The church was designed by William Railton to have "paving to be of Swithland Slate on dwarf walls".⁸ The flooring under the aisle carpet is apparently still made of local slate and the sill at the main entrance to the church is of local slate (*photo 5*).

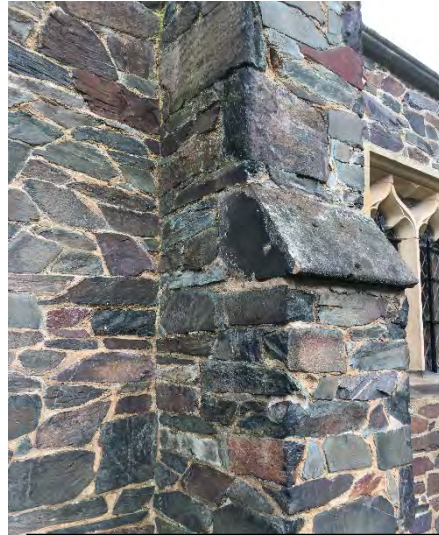
Photo 6 – Boulder stone walls

William Kirk, the builder of the original Chapel was instructed that he must acquire, as William Railton considered necessary, ".....all manner of Stones (except the Forest Stones which the said William Kirk shall be allowed to get and take from and out of the land adjoining the site of the said Chapel and the property of Ann Christiana Watkinson).....".⁹ (*photo 6*).

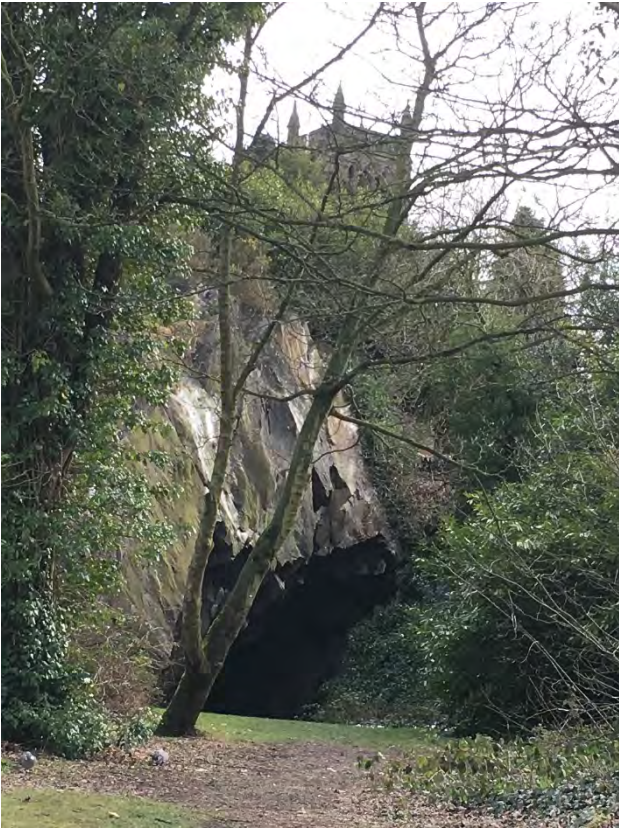
Photo 7 – St Paul's above the stone hole quarry today (left)

The church stands on top of a rocky outcrop above the Charnwood Village of Woodhouse Eaves, overlooking the Soar Valley, the main stone used as small boulders to build its walls was locally quarried (*photo 7*). This stone, of volcanic origin, does not cleave well and does not naturally form flat sections when split, it is not therefore suitable for roofing although it was often referred to as “slate”. There are 3 stone extraction sites still visible near the church today, 2 surface quarries in the Old Rectory garden and the Stone Hole quarry underneath the rock on which the church stands. The Stone Hole was certainly quarried beyond the time of the church construction and it is not clear from which pit the stone for the Chapel was extracted (*photo 8*).

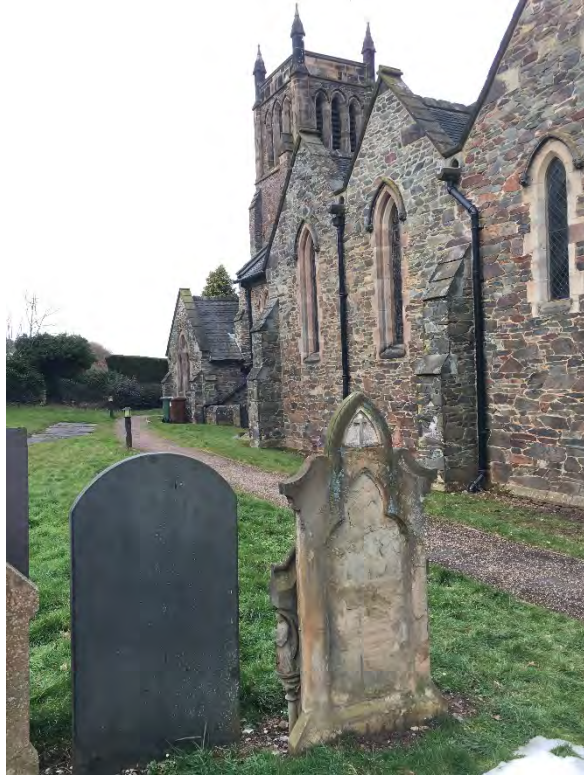
Photo 9- St Paul's gravestones, flaking softer stone on the right, Swithland slate on the left.

Many of the oldest and best preserved gravestones in St Paul's churchyard are made from Swithland slate which can lend itself to very elaborate and long lasting carving and inscriptions (*photo 9*) (*photo 10*), when compared to adjacent gravestones made of other materials. Swithland slate is extremely durable and has stood the test of time when compared to stones of softer stone of a similar date.

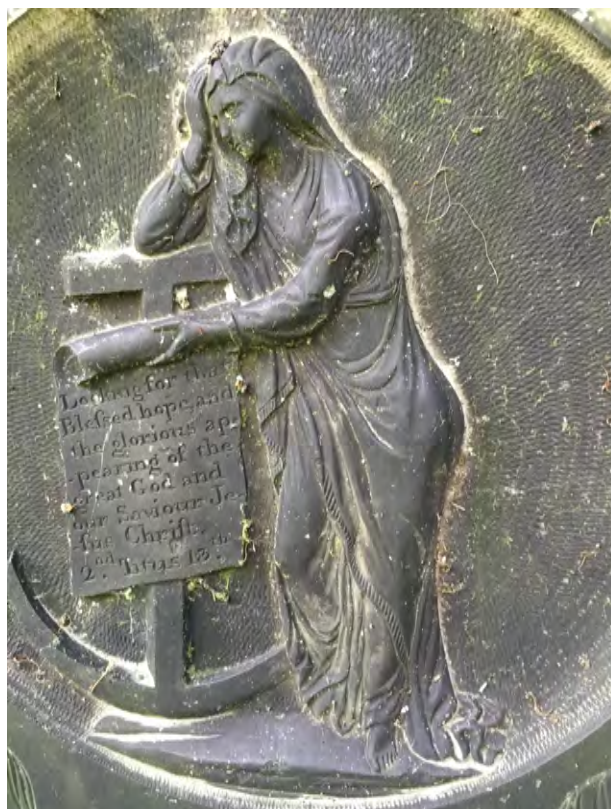
Photo 11- Carving detail on Swithland slate gravestone St Peter's Church, Belgrave, Leicester

Carving of the slate, for example for gravestones, was at first done primitively by the original slate pit workers who had extracted the stone, this improved with more sophisticated hand tools and professional stonemasons employed to do the work, some working in the quarries. The skilled craftsmen were able to produce decorations and carving in relief as well as by incision in the slate, these carvings have withstood time and weather extraordinarily well (*Photo 11*). The stones were unpolished in early production, later being polished and inscribed or decorated on one side although often leaving a rough hewn back. The Swithland slate is resistant to lichen growth as well as the effects of weather.

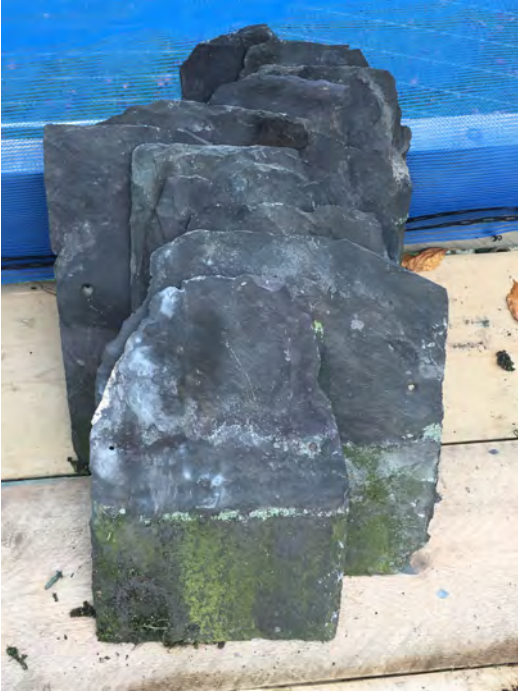
Photo 12 - Loose slates in piles before being re-fitted to St Paul's chancel

Swithland slate roof tiles are extremely hard wearing, dense and resistant to break down by weather or lichens etc. (*Photo 12*). They are beautiful materials with a wide variety of colours in the stone and they are unlikely to ever need replacing due to wear or spontaneous cracking and, as such, are a valuable asset to the church (*photo 13*).

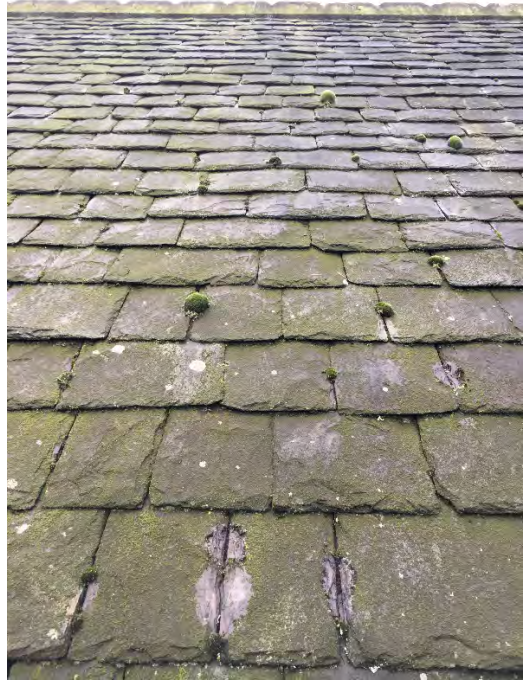
Photo 13 - St Paul's chancel roof

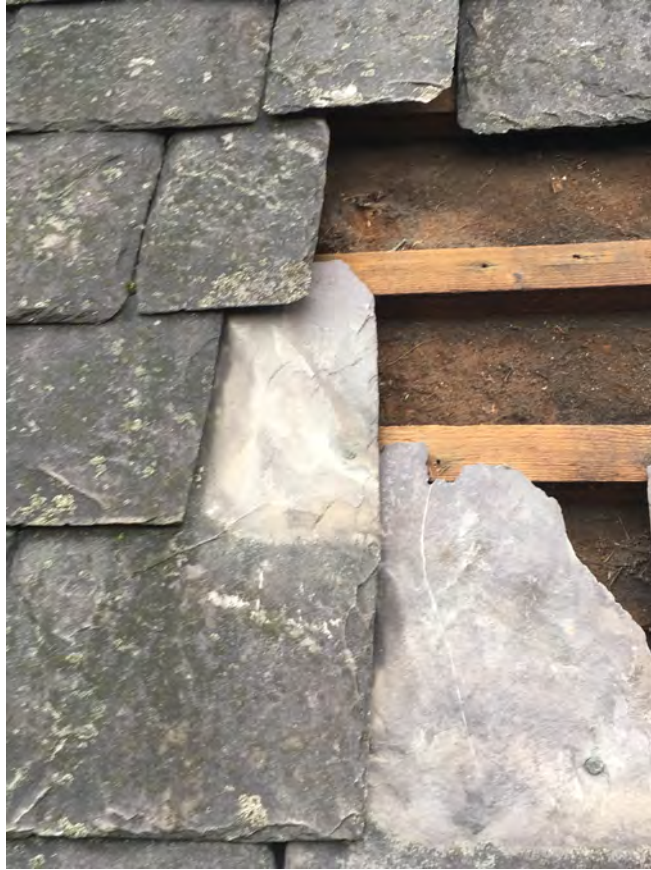
Photo 14 - Overlapping tiles on chancel roof, each one partly under the 2 above

Each tile is overlapped at its top edge by the two tiles lying above it on the roof. If the tiles do not have this significant overlap then they will apparently leak (*photo 14*) To use the quarried slate economically the tiles were made in steadily increasing sizes and were sized and shaped by holding the cleaved slate in a frame and chipping off the edges of the slate to the required size (The 2017 chancel repair contractors indicated that this technique is still used sometimes today during roof repairs). (*Photo 15*)

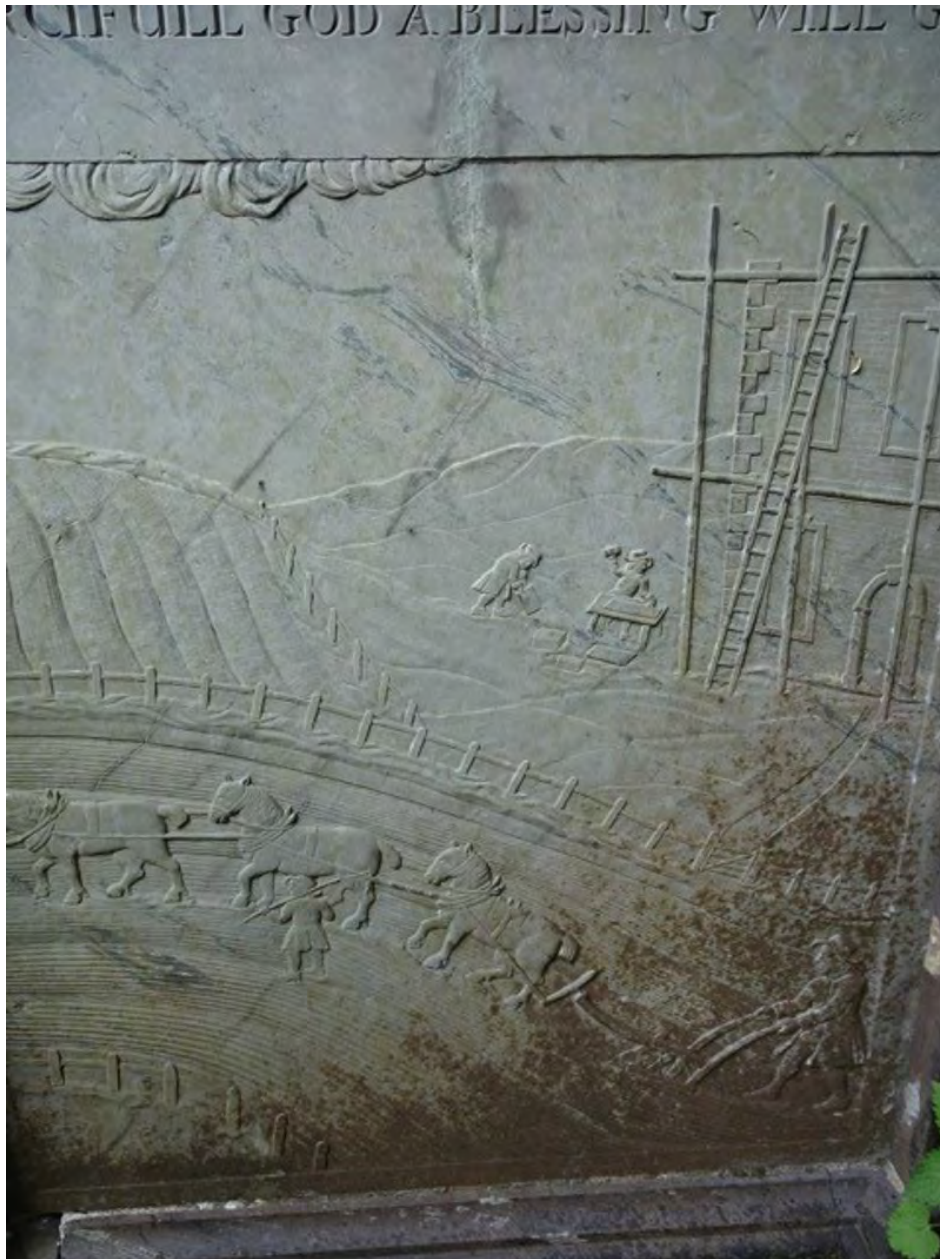
Photo 15 - Detail on Swithland slate grave in St Leonard's churchyard, Swithland, showing slate roof tiles being made, note the ladder to the roof of the house under construction

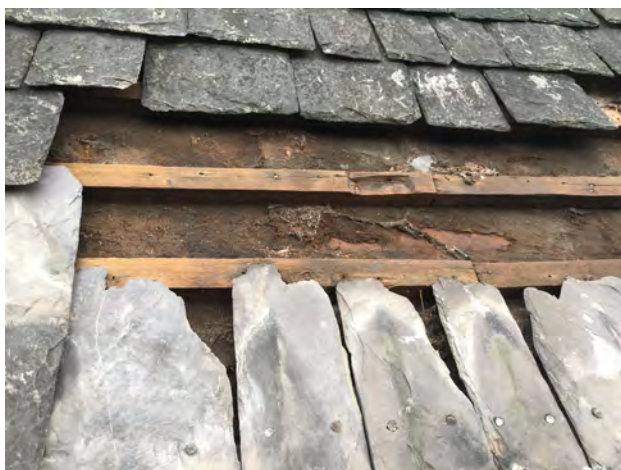
Photo 16 – St Paul's chancel roof, exposed batons and roof lining

During the chancel repair roof works in **2017** the roof tiles of the chancel were removed in 4 areas during the repairs and the old batons to which they were nailed, as well as the very old insulating tar based material lining the vaulted roof, were in good condition and did not need to be replaced (*photo 16*). The removal of the tiles revealed the green tinged copper nails used to hang the tiles in Victorian times (*photo 17*), when the tiles were replaced they were again nailed in place with copper nails. The tiles are removed with a special tile remover (*photo 18*), the tip slides under the tile and hooks over a supporting nail then is sharply knocked to remove the nail from the wood baton, this is repeated with the second nail and the tile is removed. The tiles are stacked in a particular order for ease when replacing them. The tiles removed from the chancel roof had to be replaced with small gaps under some of them, just as they were before they were removed, so that the bats that over-summer there can crawl back under the tiles and never know they have been moved!

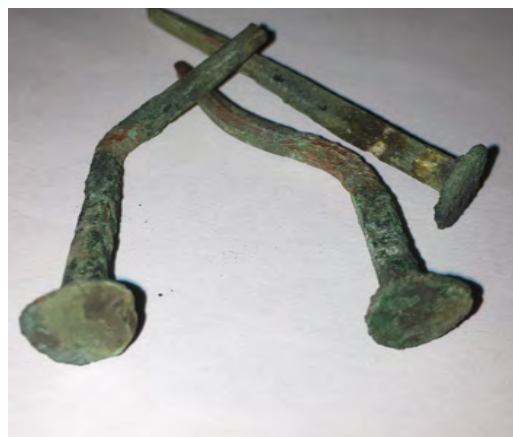
Photo 17 – Old copper nails removed when tiles were taken off the roof

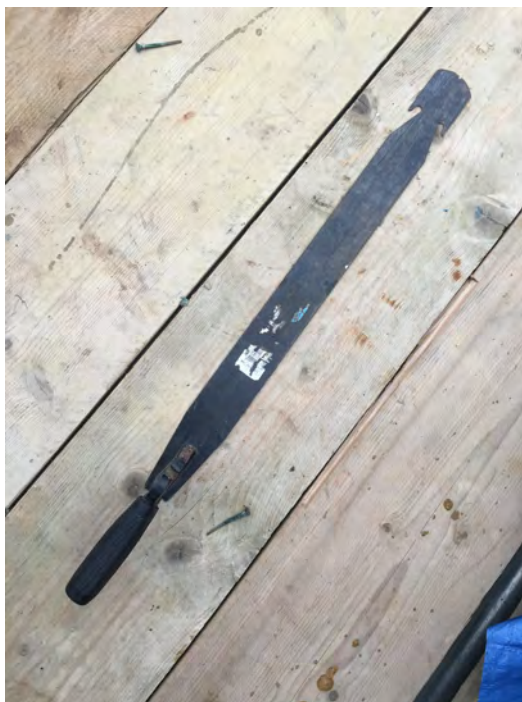
Photo 17 – Swithland slate tile removing tool, note the nails lying on the boards by the tool
