## St Paul's Chancel Repair Project progress

It is already New Year 2018 and there has been a lot to celebrate at St Paul's Church, Woodhouse Eaves, in terms of the Chancel Repair Project.

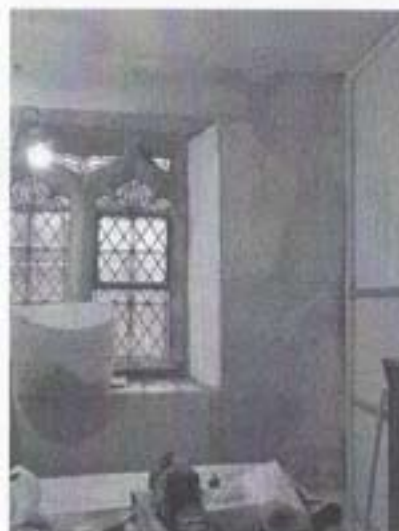
Plastering over the vestry crack repairs and replaced lintel above the window.

the walls of the chancel and vestry, following copious water leakage as the drill went through the walls for the internal metal rod supports, had been dried out and scraped off. The cracks in the walls had metal wires laid across them to add support when they were re-mortared. An expert plasterer used lime plaster, like that originally used, to disguise the multiple sites where the walls had been repaired.

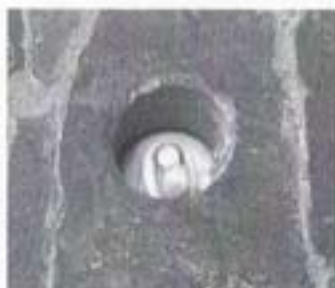
The end of one of the metal supporting rods in the chancel walls before it was sealed.

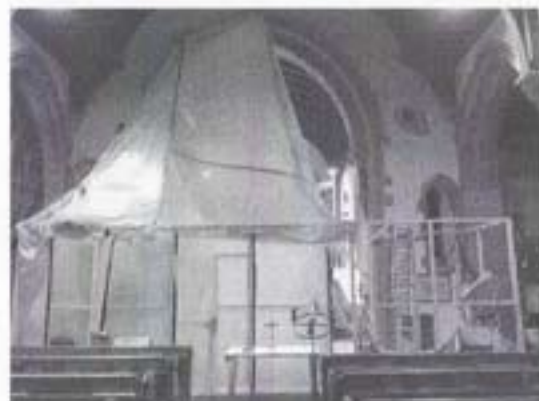
The 'canopy' put up to protect the body of the church from dust and dirt coming down at the end of the works.

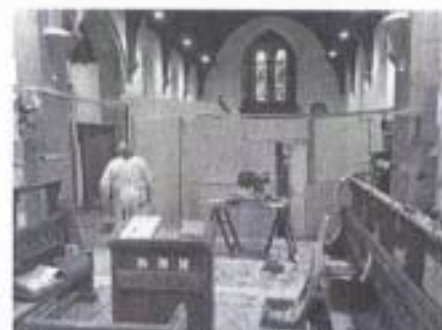
Work nearing completion in the chancel.
